Ashburton Salt Project: Interim Mine
Closure Plan Tenement Number
M08/0535

Tenement Holder:
K plus S Salt Australia Pty Ltd (K+S)

22 December 2022

Version 1, Revision 1.1
Mining Tenement Number M08/0535
Site Name and Code: To be assigned by DMIRS

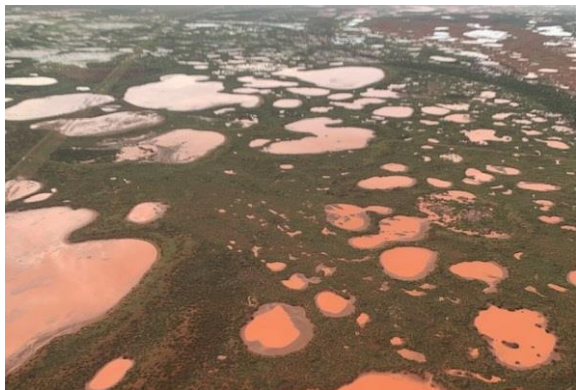
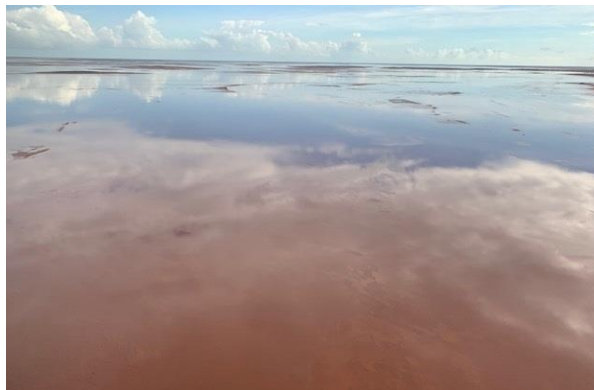
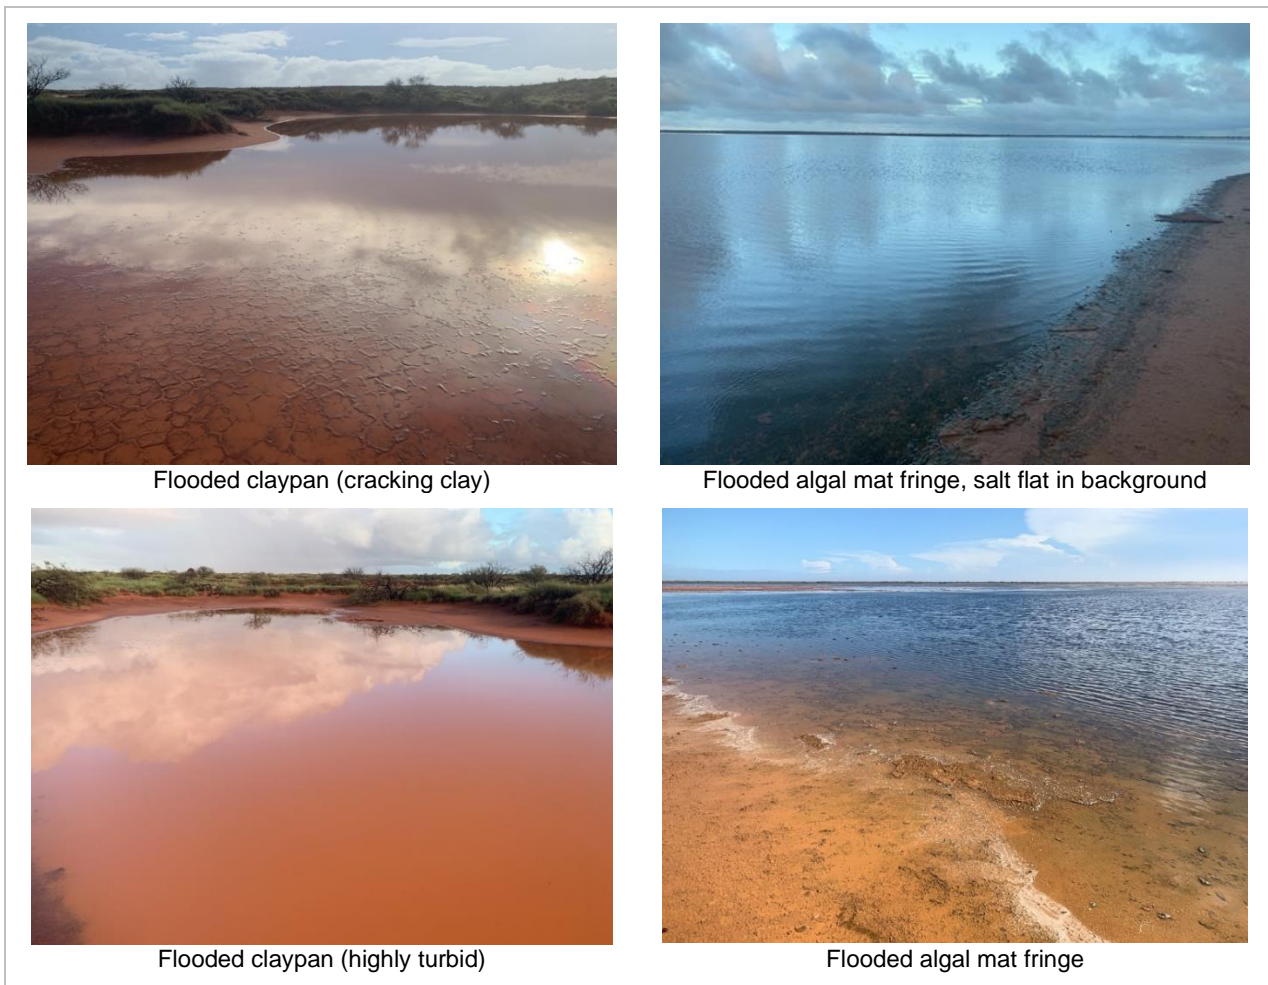
Figure 16: Photographs of Surface Water Flooding after Rainfall on 13th of April 2019

Aerial view of flooded claypans from helicopter

Large expanse of flooded salt flat
